Debris/Ice/TPS Assessment and Integrated Photographic Analysis of Shuttle Mission STS-69

Gregory N. Katnik, Barry C. Bowen, J. Bradley Davis

DEBRIS/ICE/TPS ASSESSMENT
AND
INTEGRATED PHOTOGRAPHIC ANALYSIS
OF
SHUTTLE MISSION STS-69

7 September 1995

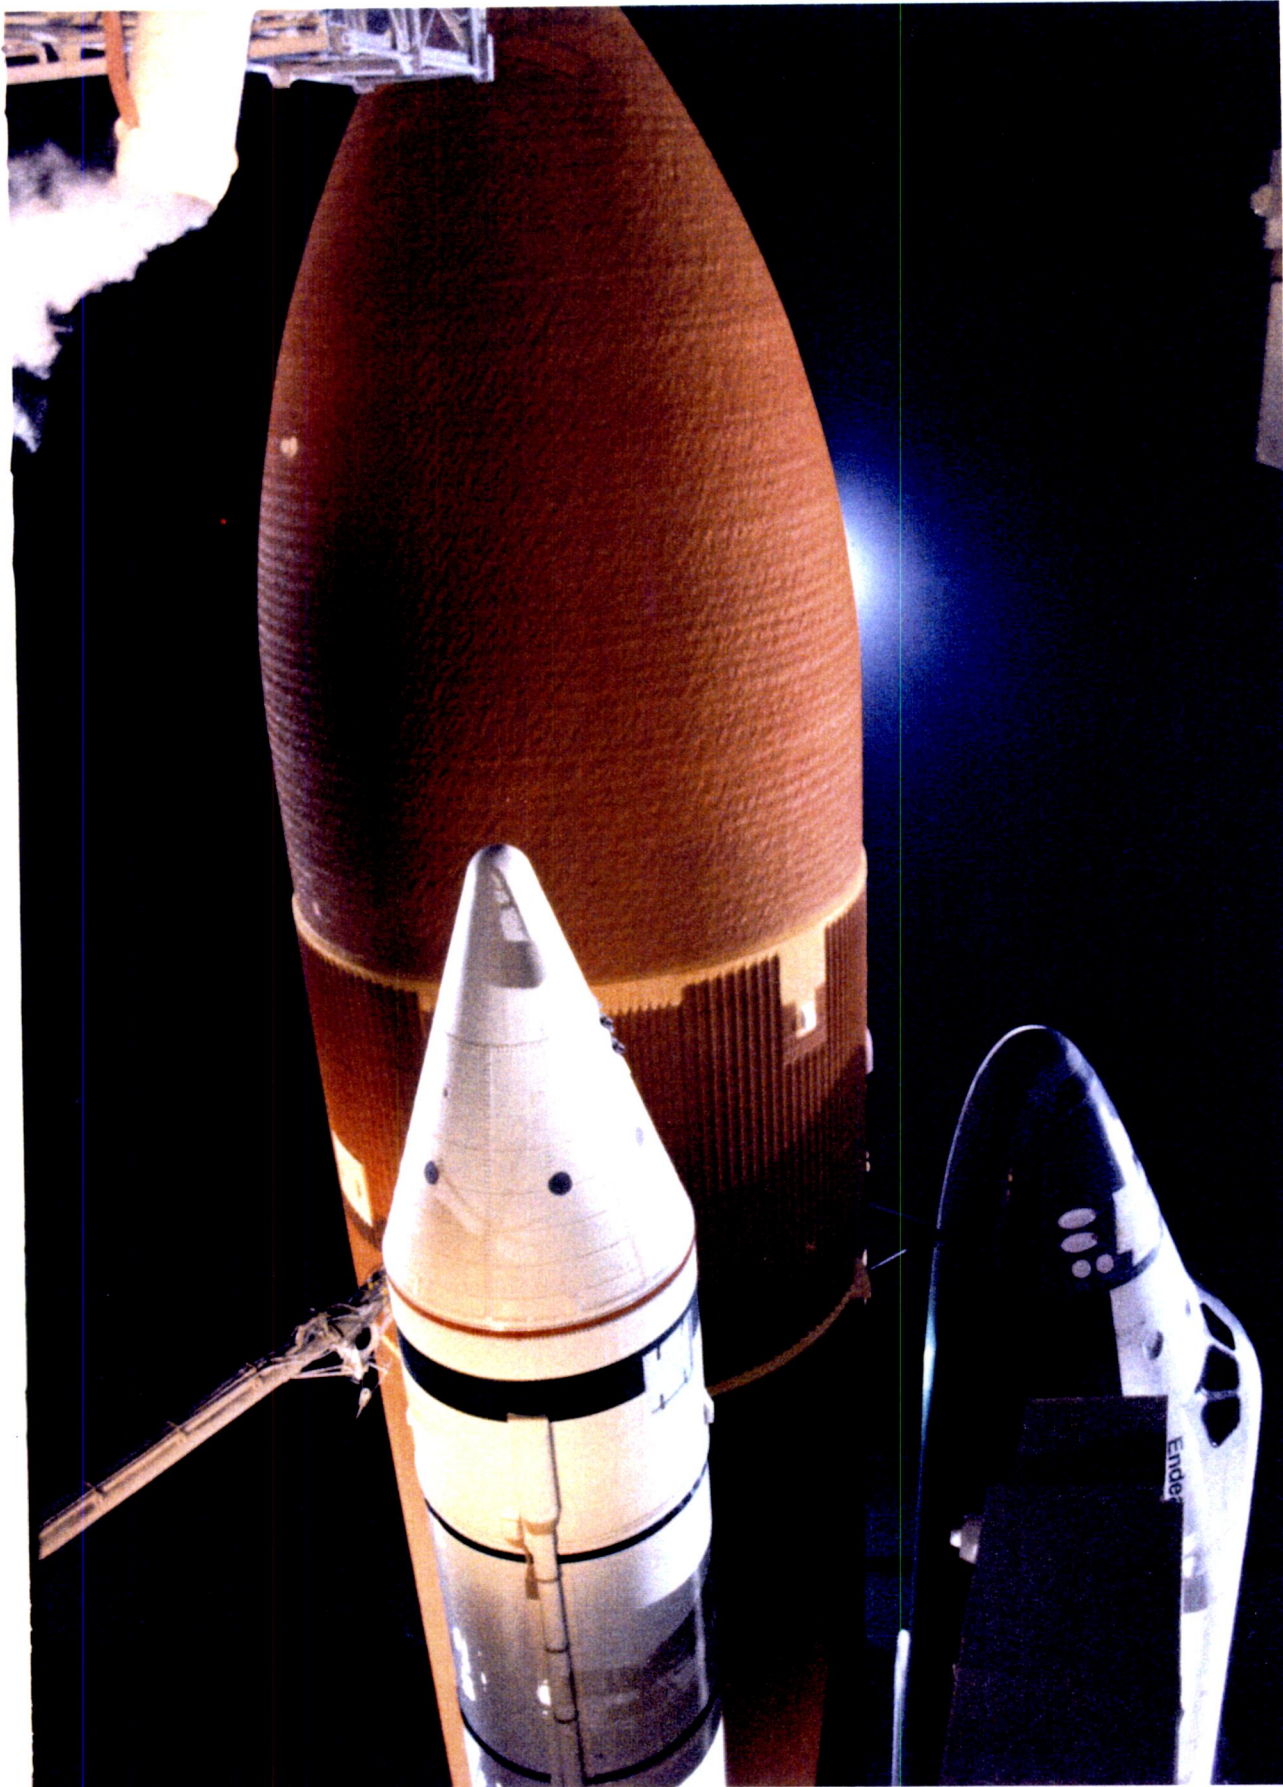
Photo 3 : Cryoloaded External Tank

No acreage ice/frost conditions or TPS anomalies

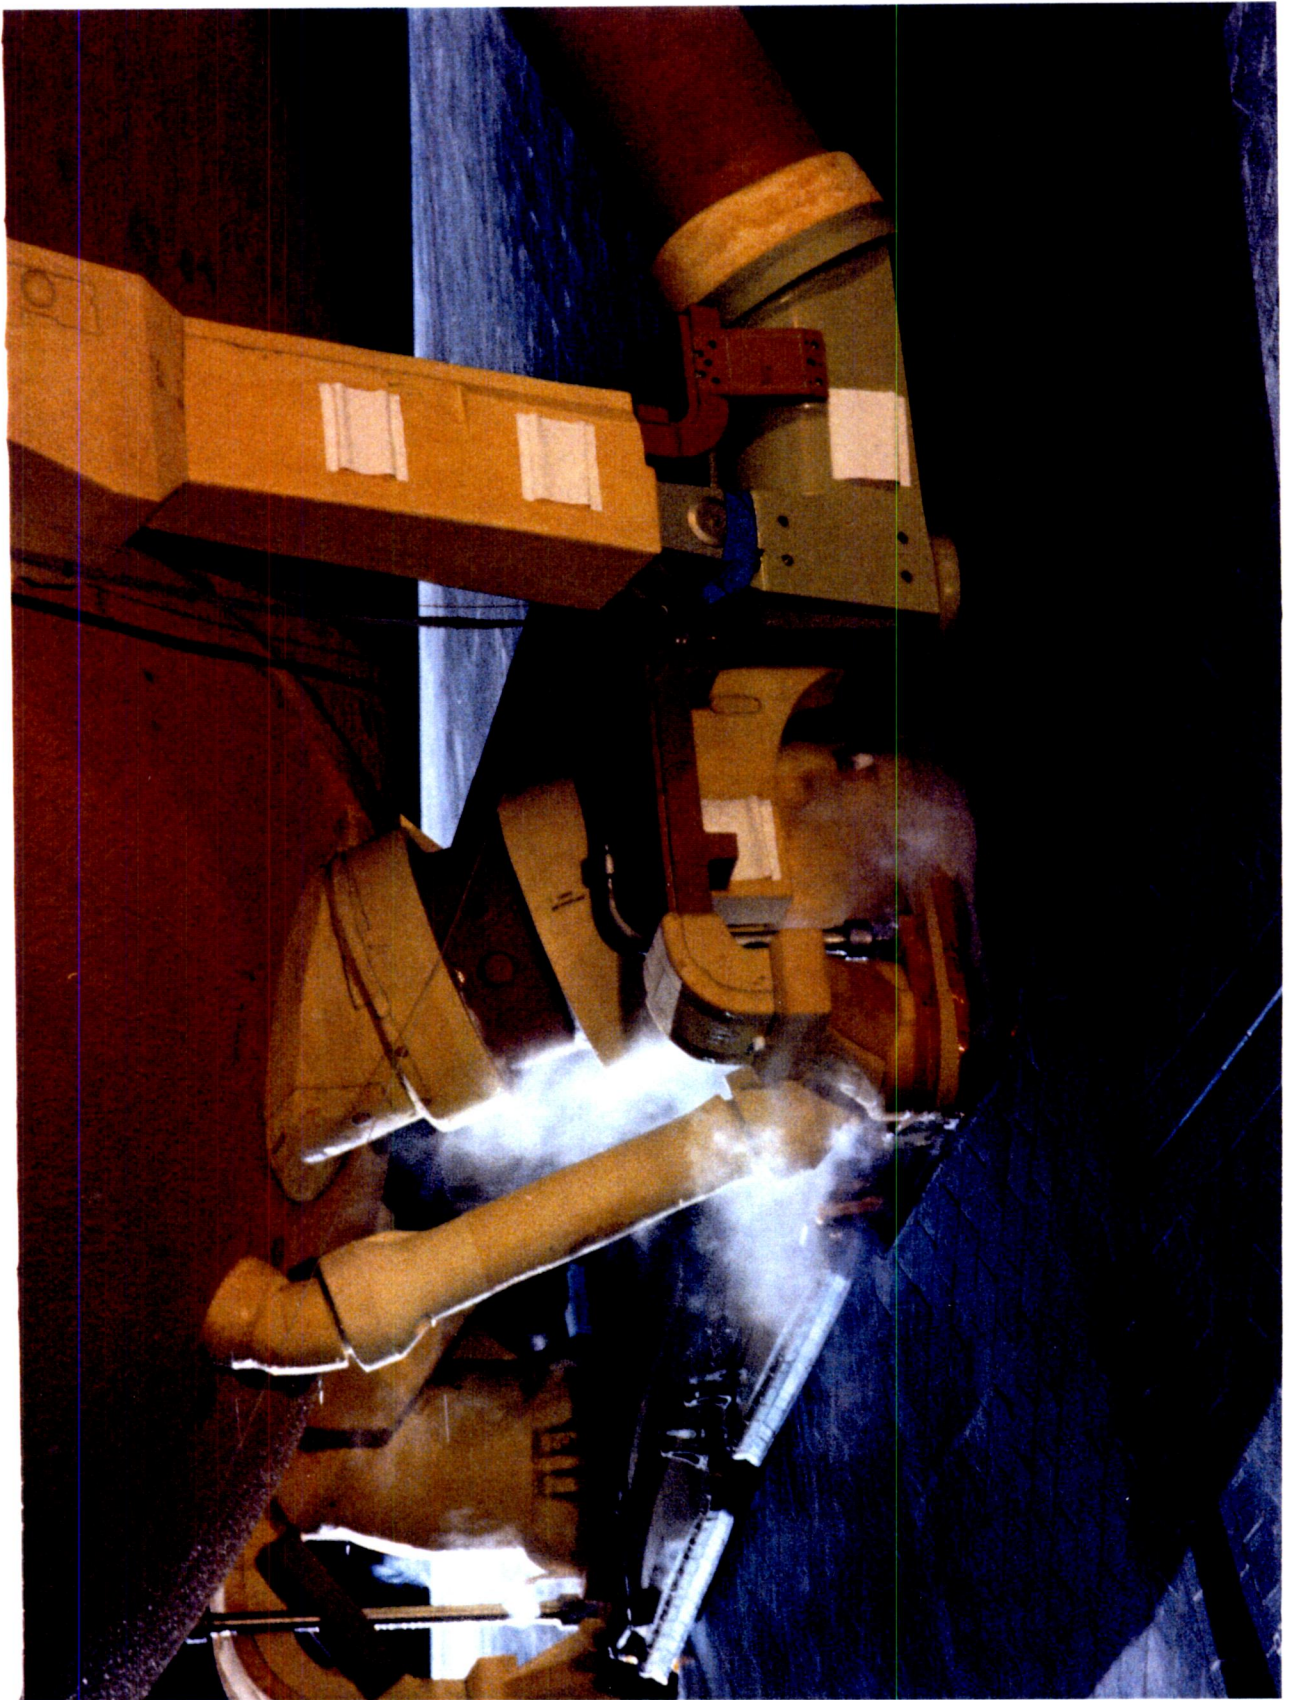
Photo 4 : LH2 ET/ORB Umbilical

Typical amounts of ice/frost had accumulated on the LH2 ET/ORB umbilical purge barrier top and outboard sides. Ice/frost fingers were present on the pyro canister and plate gap purge vents. No unusual vapors or cryogenic drips had appeared during tanking, stable replenish, and launch.

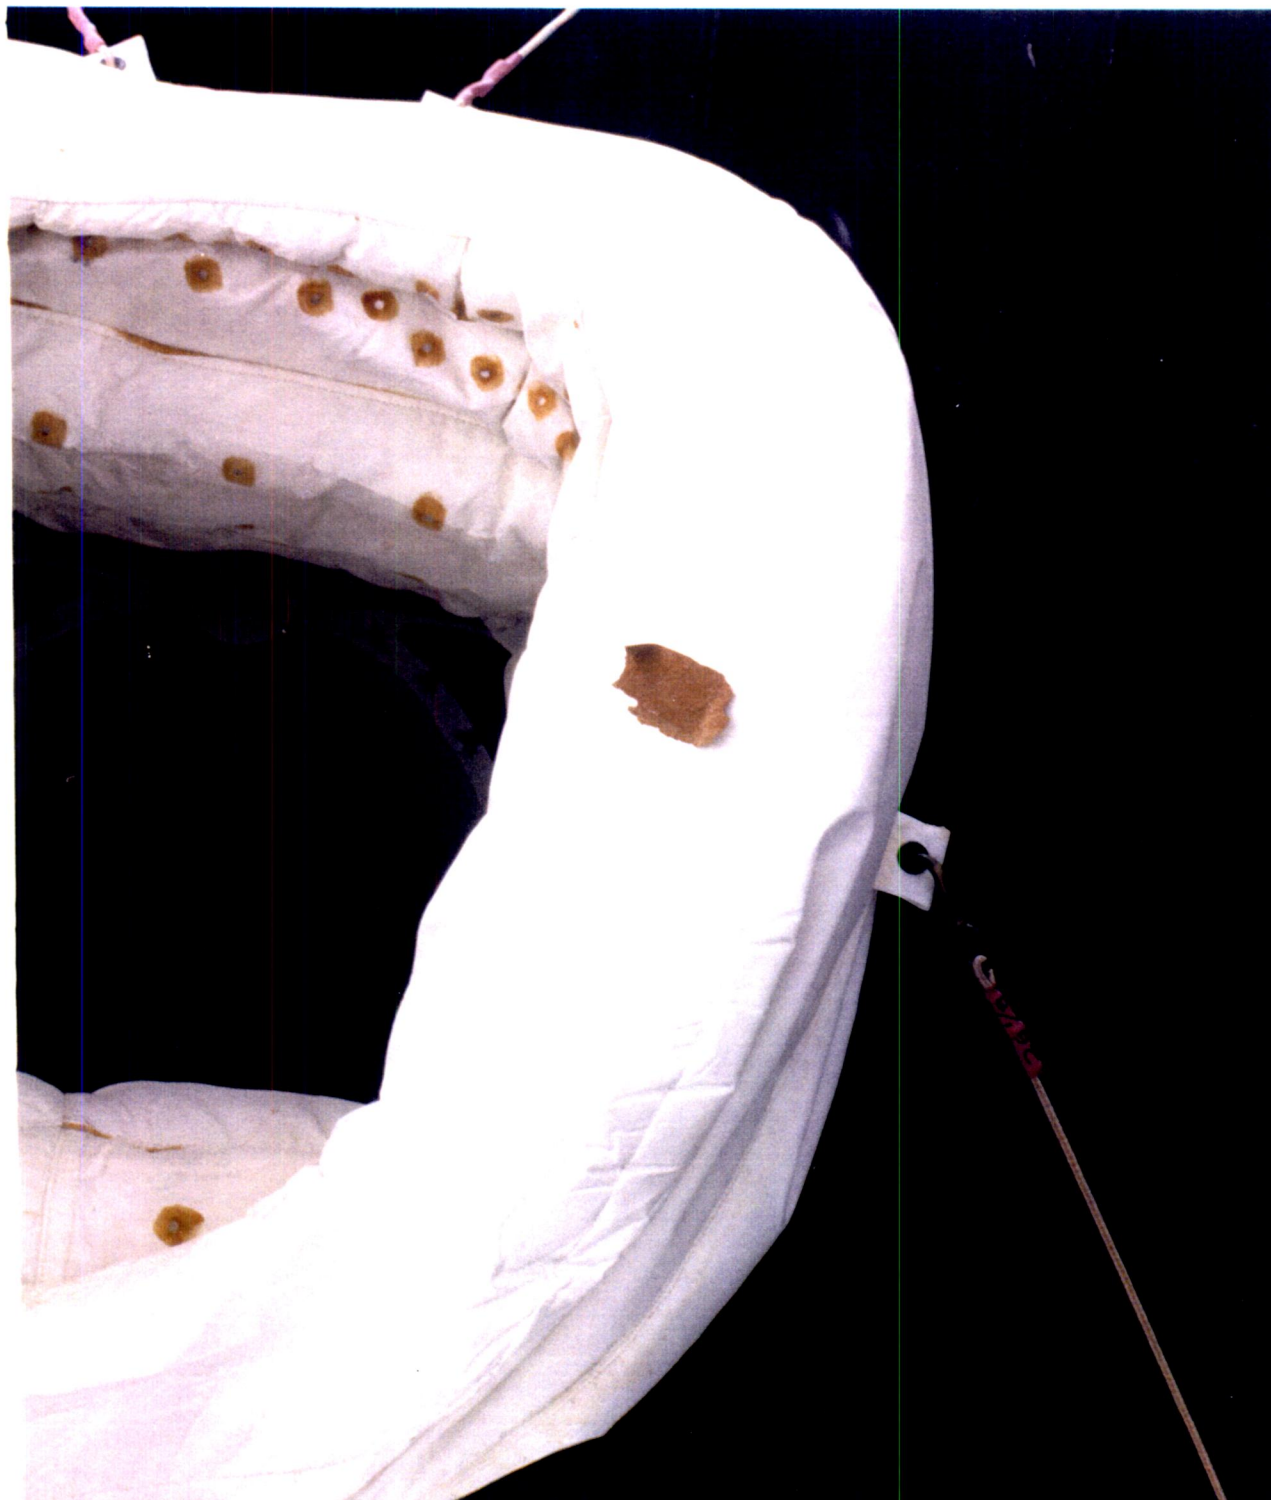
Photo 5 : Nose Cone Topcoat Adhered to GOX Vent Seal

Multiple areas of ET nose cone topcoat adhered to both GOX vent seals. One large area, measuring 3-inches long by 1.5 inches wide, was located on the northeast seal.

The seals stuck momentarily to the ET nose cone during GOX vent hood retraction at T-2:30 minutes. An area of topcoat, 3 inches long by 1.5 inches wide, adhered to the northeast seal, but no foam residue from the ET was present.

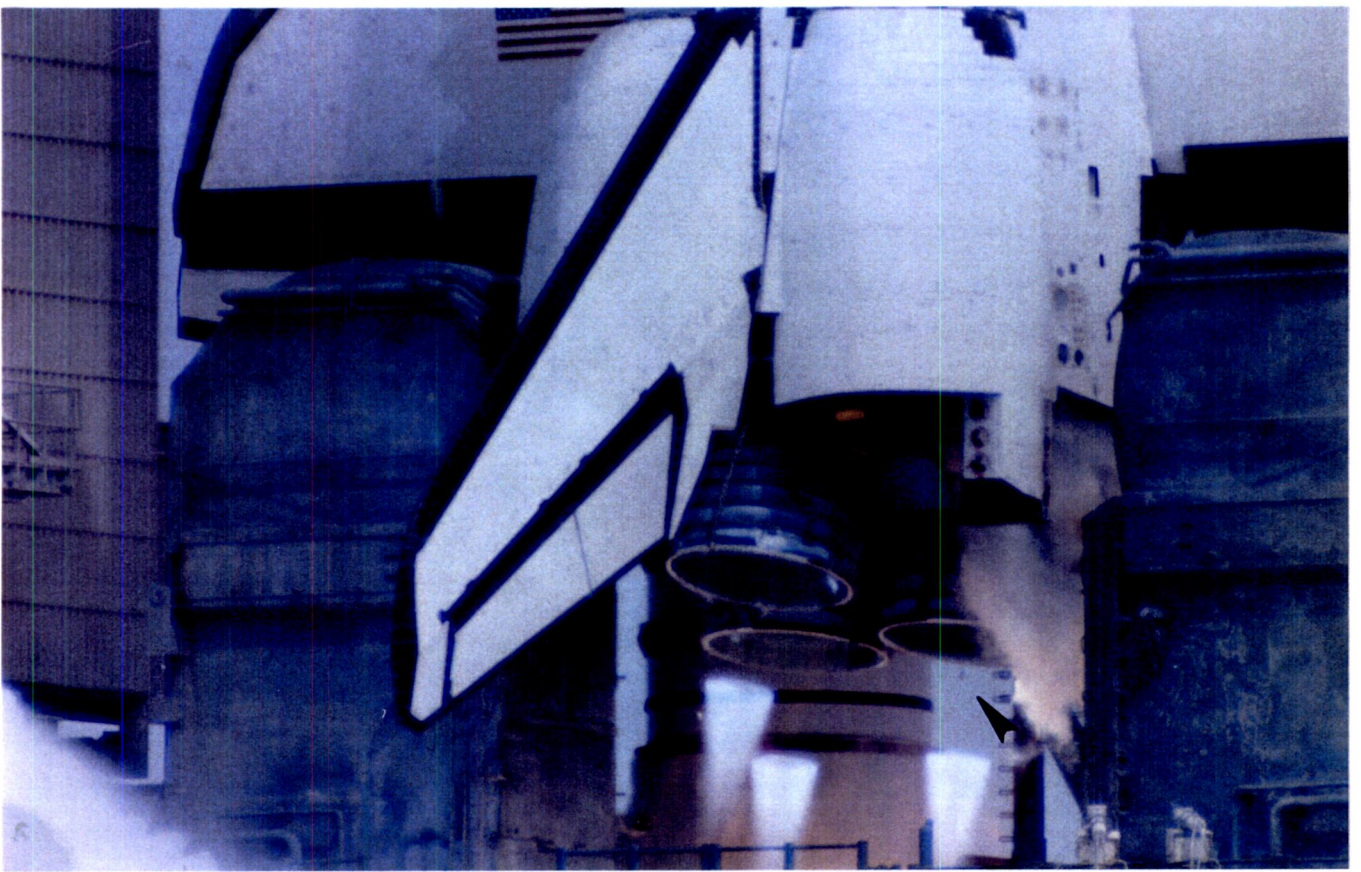
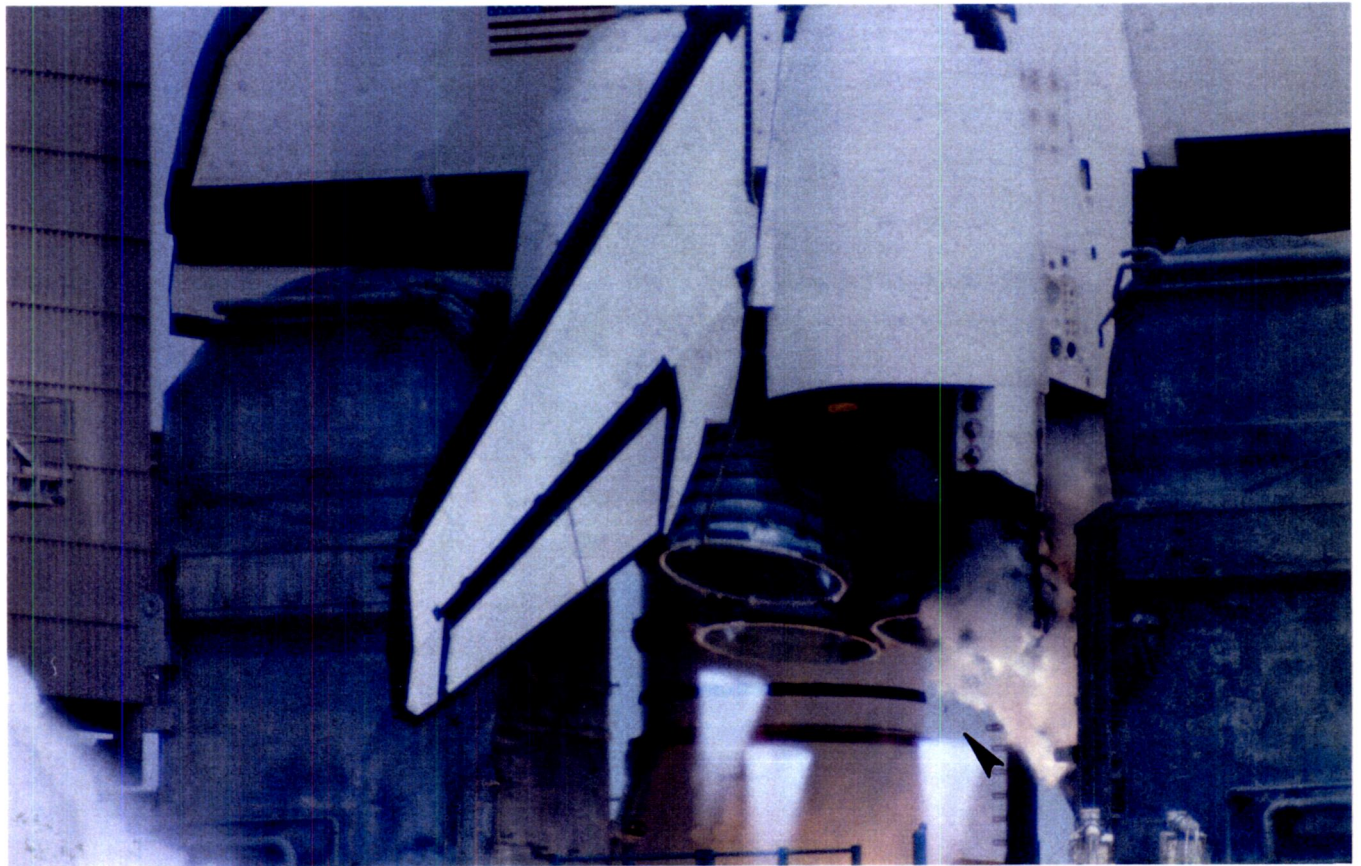
Photo 6 : Debris Prior to Liftoff

A dark object appeared behind the SSME #2 and #3 nozzles at 0.9 seconds MET (15:09:00.883 GMT) and fell aft into the SSME plume. The object was originally thought to be a piece of a body flap stub tile from the body flap hinge area (E-19, -76, -77). However, post landing inspection of the Orbiter revealed no missing stub tile pieces. The object was probably a tile gap filler.

A dark object appeared behind the SSME #2 and #3 nozzles at 0.9 seconds MET (15:09:00.883 GMT) and fell aft into the SSME plume. Post landing inspection of the Orbiter revealed no missing body flap stub tiles pieces. The object is believed to be a tile gap filler.

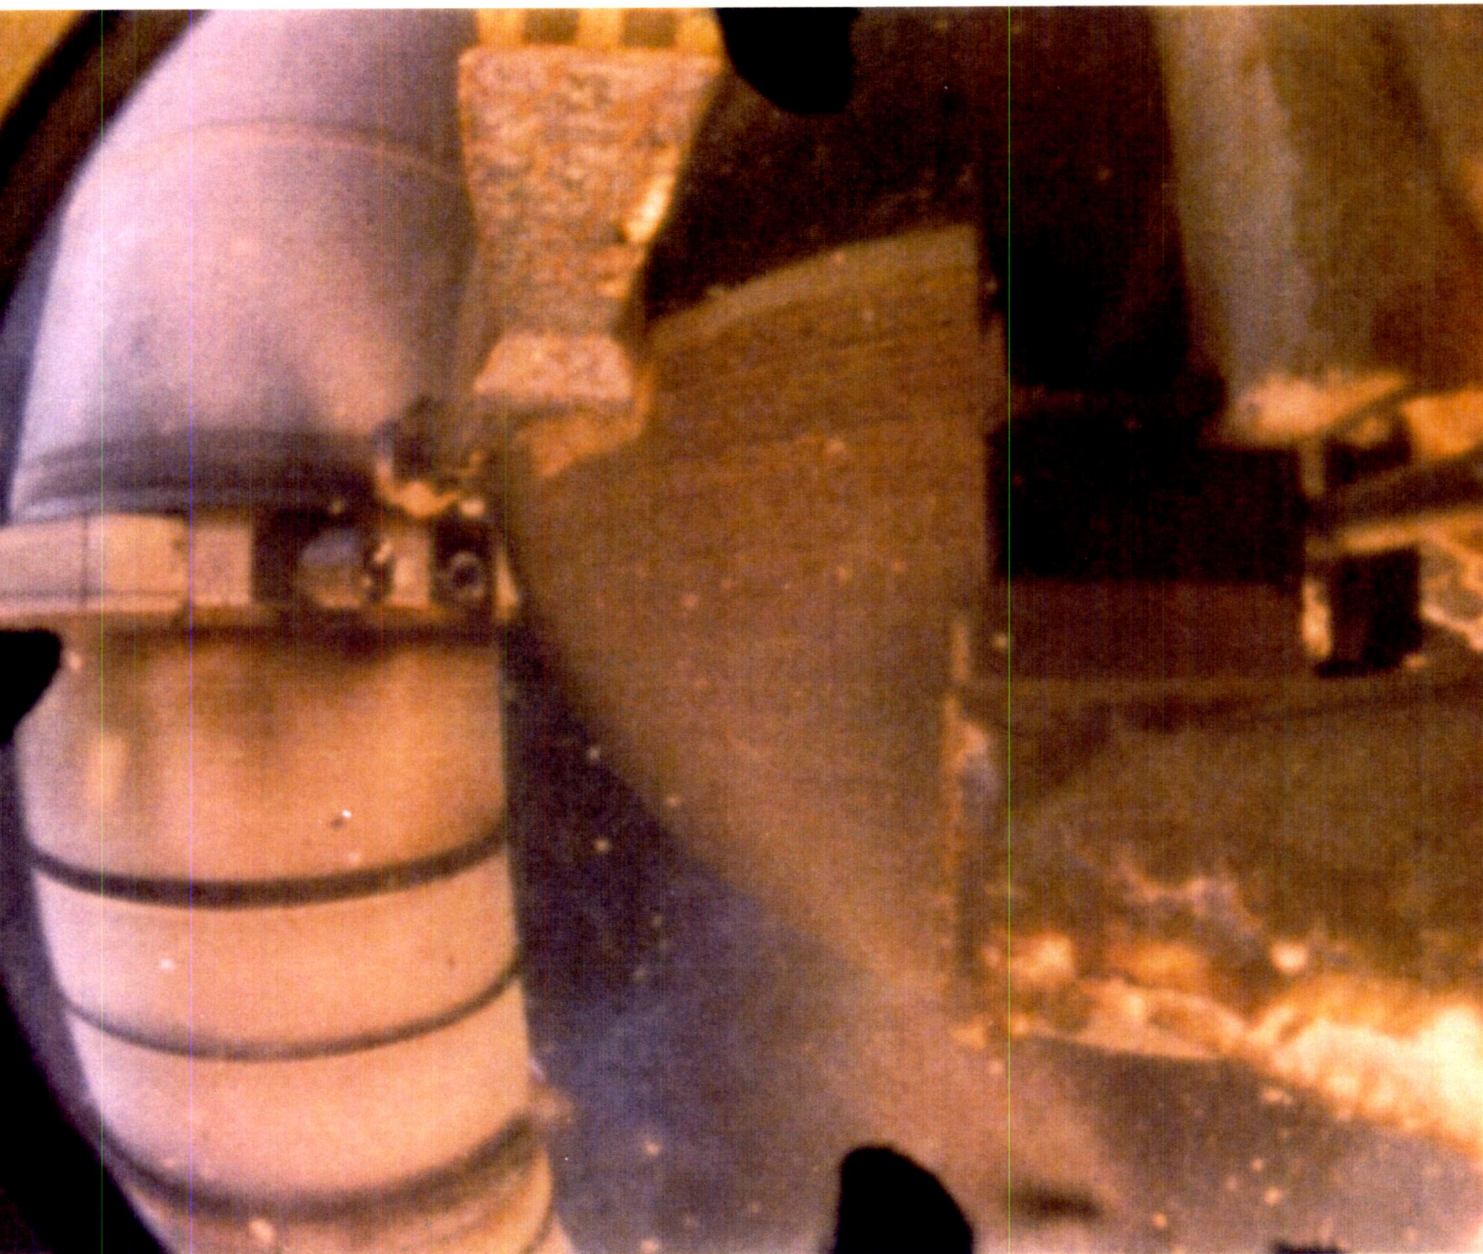
Photo 7 : SRB Separation from External Tank

SRB separation from the External Tank was nominal. More than usual, but small, pieces of foam fell past the camera lens. Charring/erosion of foam on the aft surfaces of the -Y vertical strut and LH2 ET/ORB umbilical cable tray was typical.

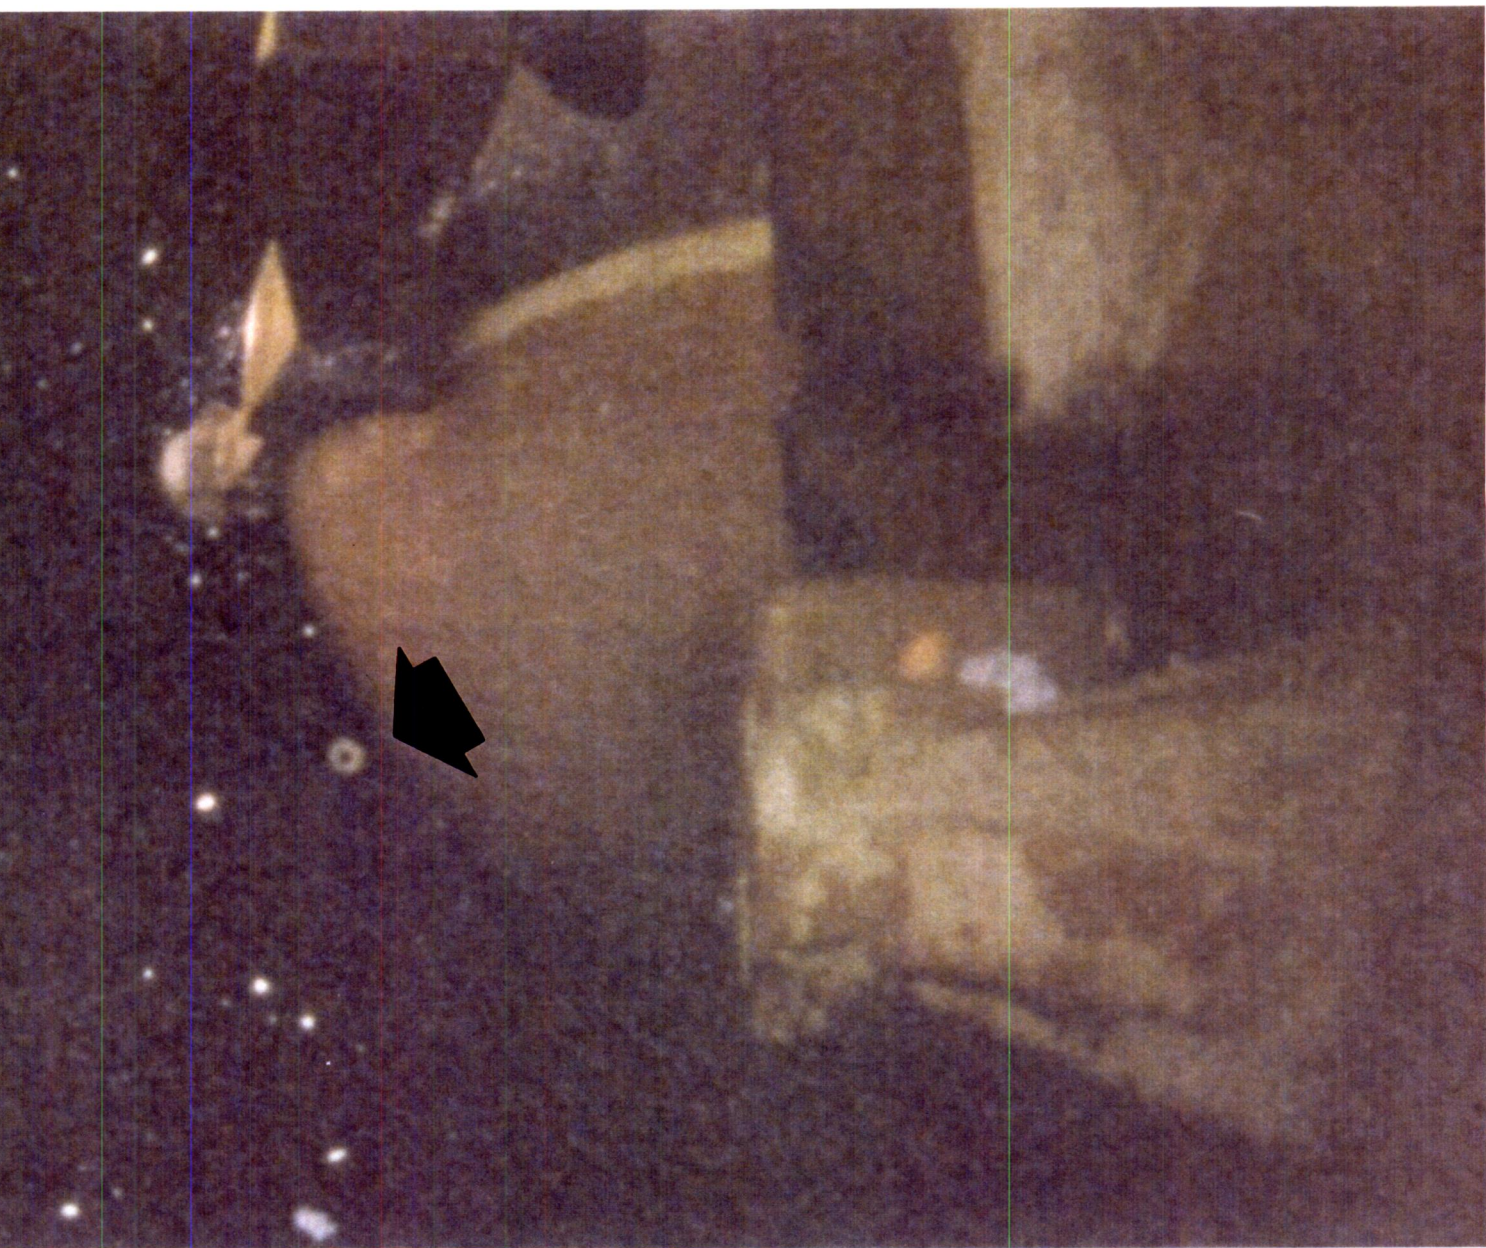
Photo 8 : Loose Metallic Washer

A thin, metallic, 1/2-inch diameter washer (arrow) originated from an area behind the LH2 ET/ORB umbilical cable tray after umbilical separation (5mm film, frame 4230) and drifted generally in the -Y-Z direction. The washer could not be identified as flight hardware.

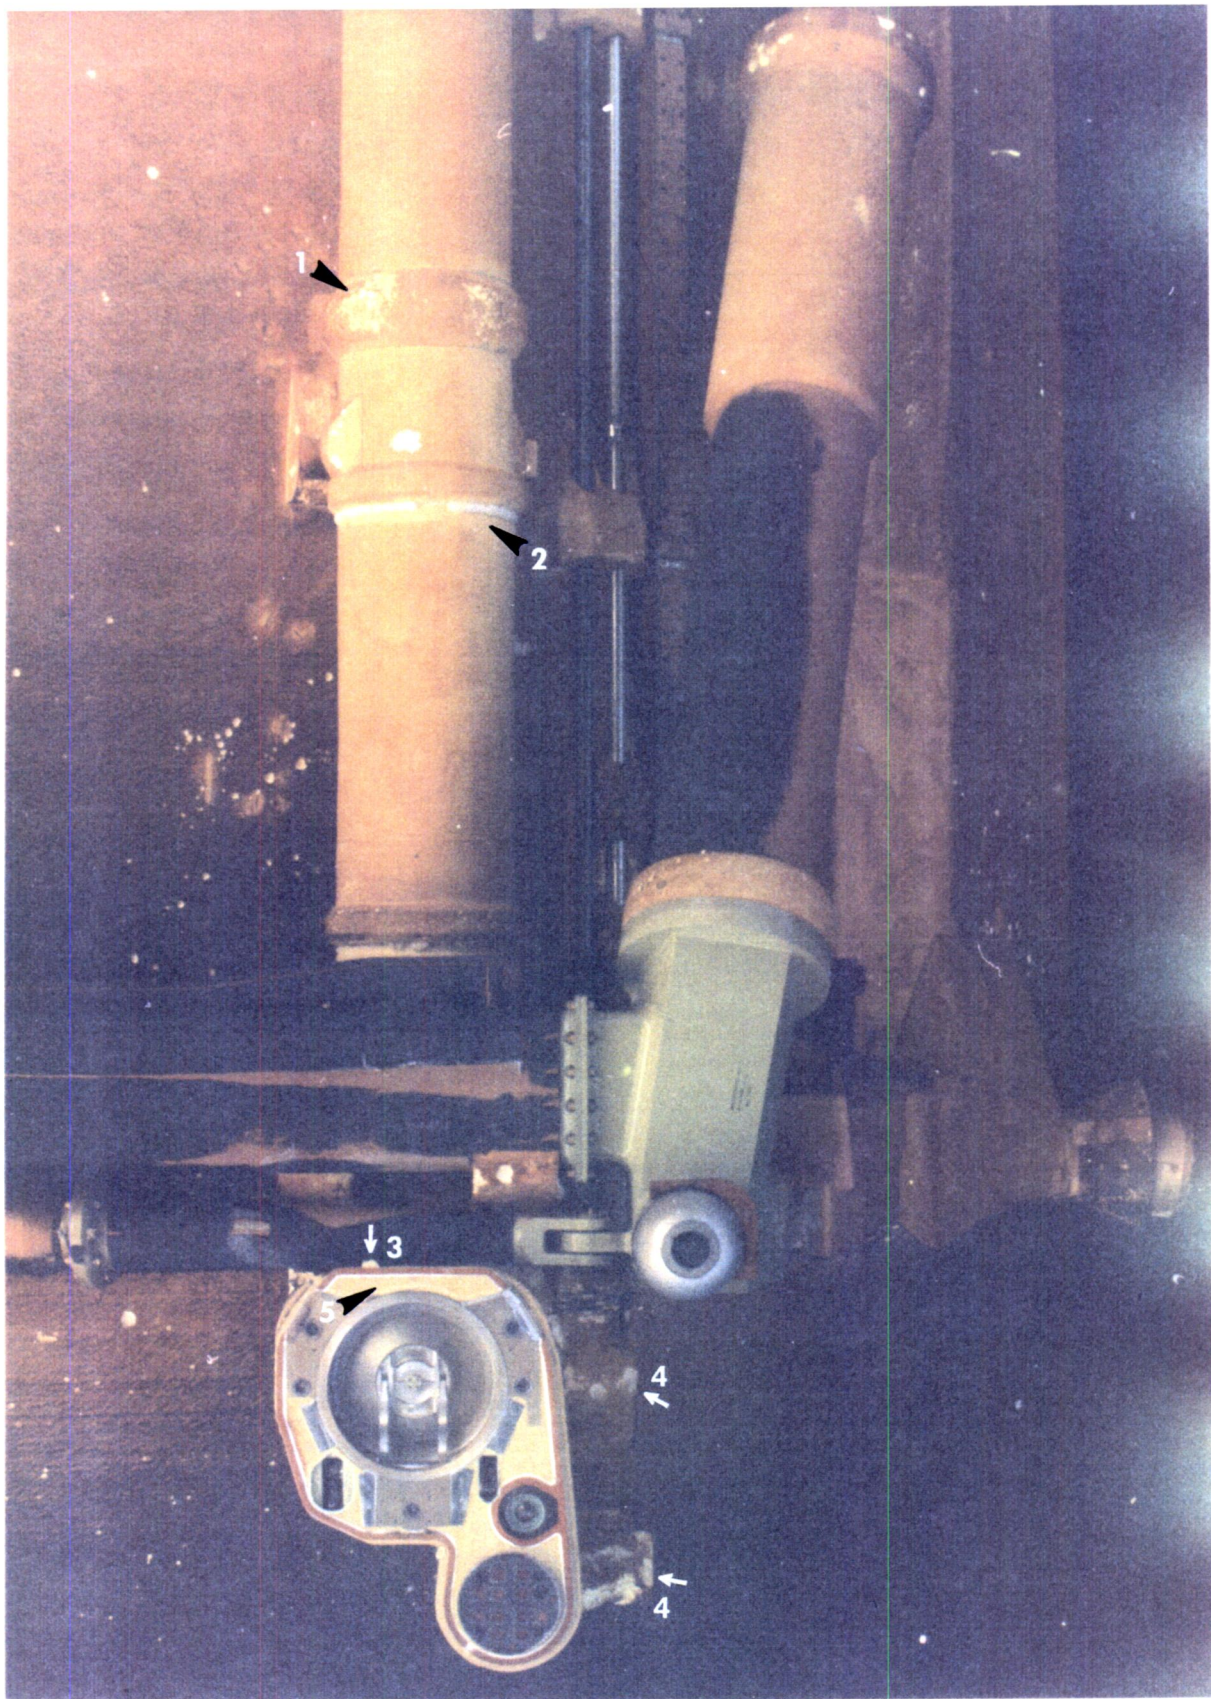
Photo 9 : LO2 ET/ORB Umbilical

The LO2 ET/ORB umbilical sustained minor TPS damage on the forward surface. Numerous divots and eroded areas were visible on the horizontal and vertical sections of the cable tray. The lightning contact strip across the forward part of the umbilical was missing. Loss of lightning contact strips was the subject of a previous IFA and occurred on STS-57, -58, -65, -66, and -71.

The LO2 feedline flange TPS closeout exhibited minor erosion (1). Ice was still present in the feedline lower bellows (2). The LO2 ET/ORB umbilical sustained minor TPS damage on the forward surface (3). Numerous divots and eroded areas were visible on the horizontal and vertical sections of the cable tray (4). The lightning contact strip across the forward part of the umbilical was missing (5).

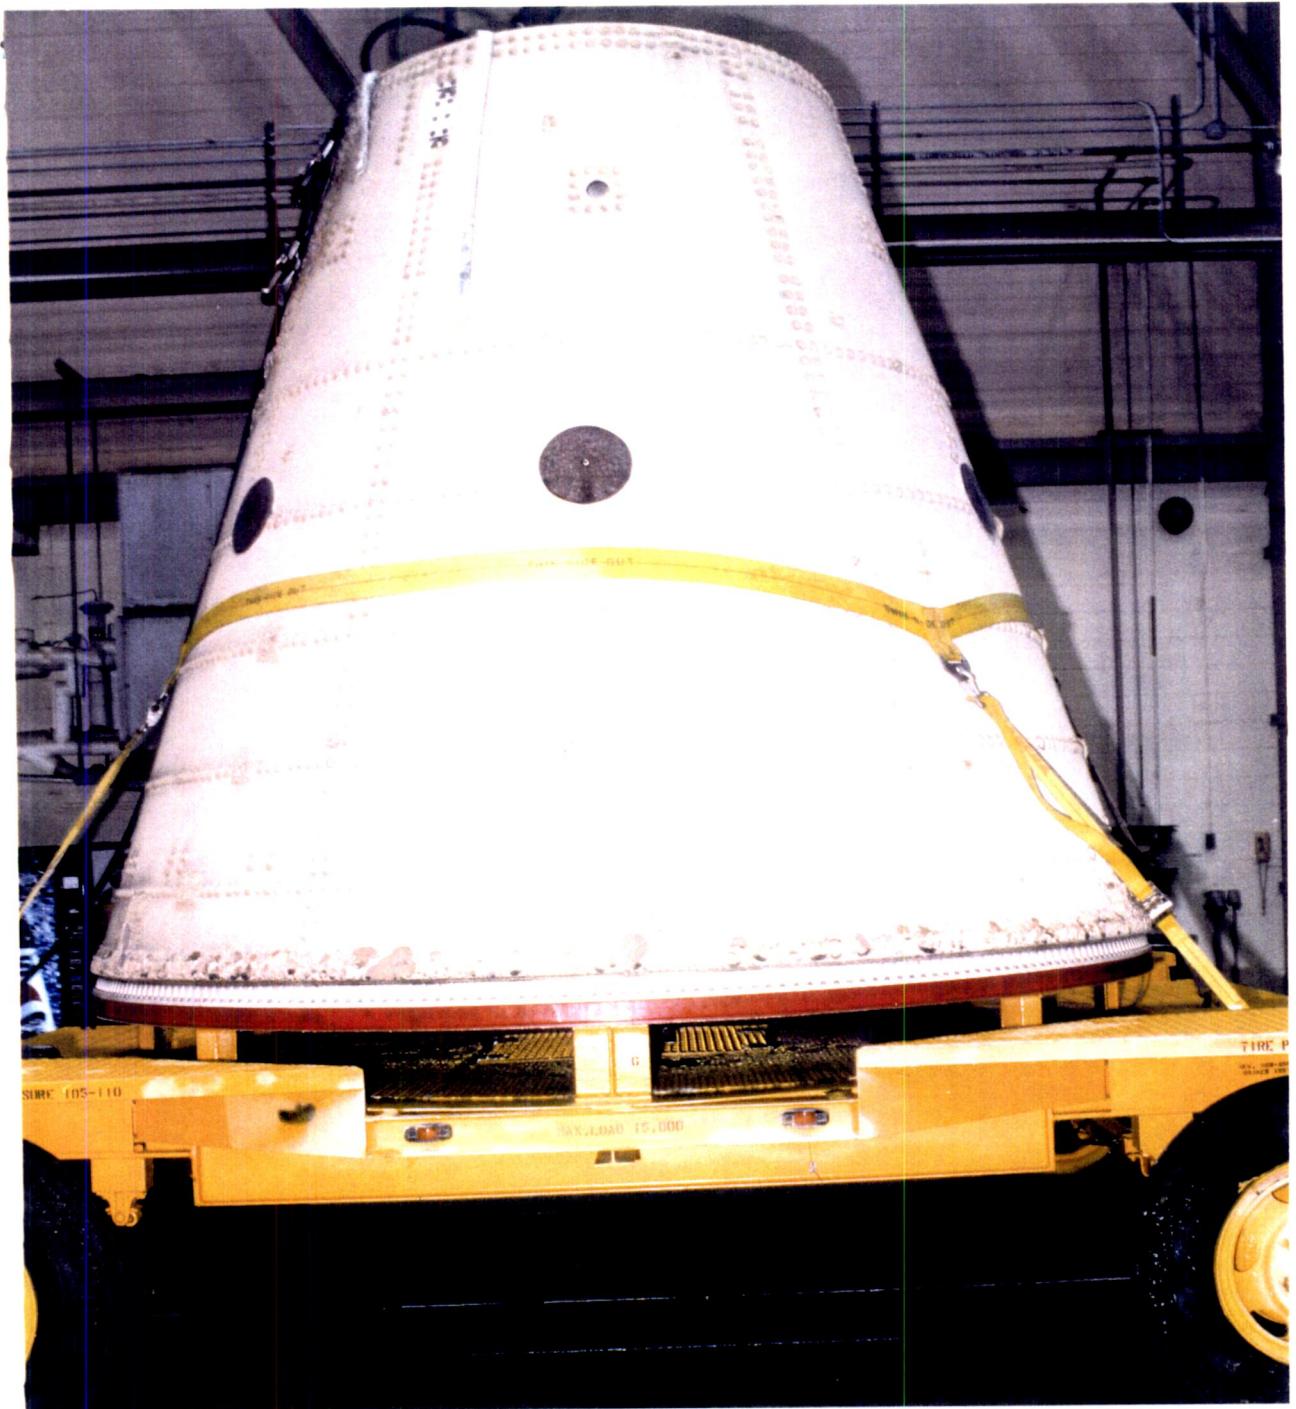
Photo 10 : RH Frustum

The RH frustum was missing no TPS. The number of debonds (80) over fasteners was greater than average. Hypalon paint was blistered/missing along the XB-395 ring frame where BTA closeouts had been applied. Some of the underlying BTA was sooted.

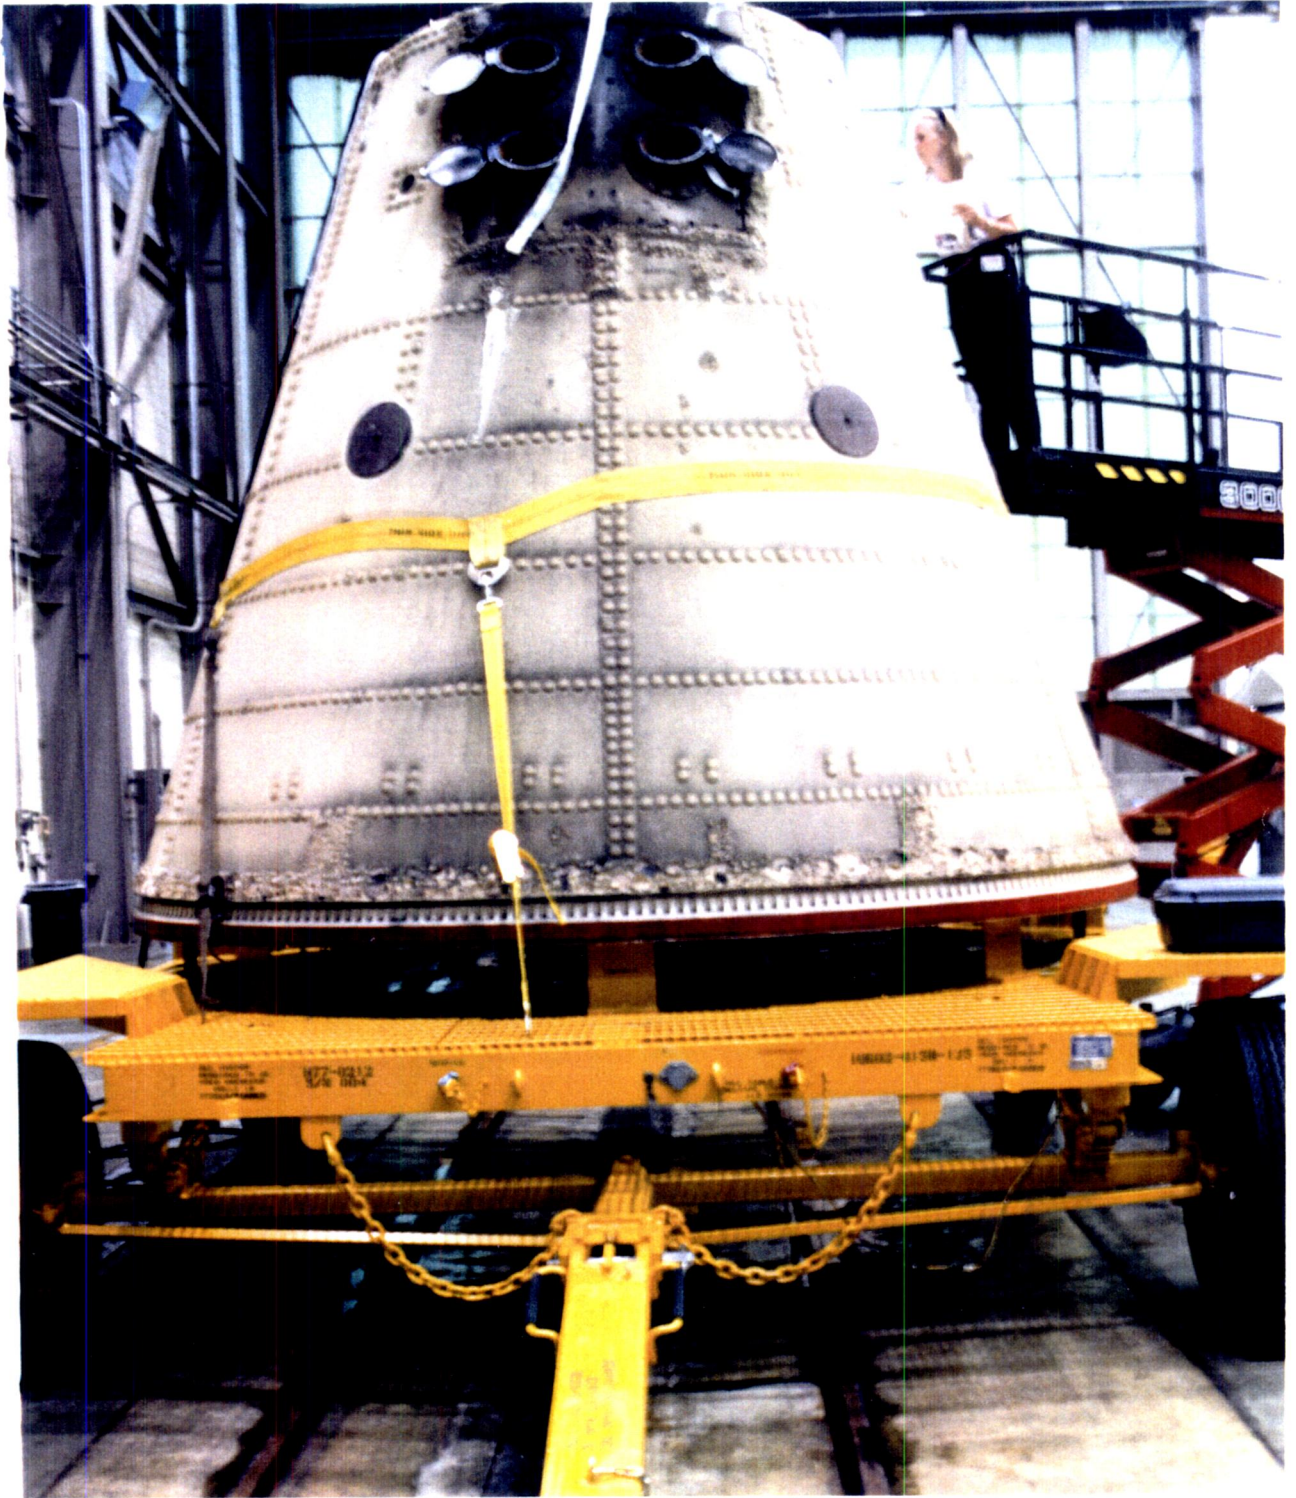
Photo 13 : LH Frustum

The LH frustum was missing no TPS. The number of MSA-2 debonds (63) over fasteners was greater than average. Hypalon paint was blistered/missing along the XB-395 ring frame where BTA closeouts had been applied. Some of the underlying BTA was sooted.

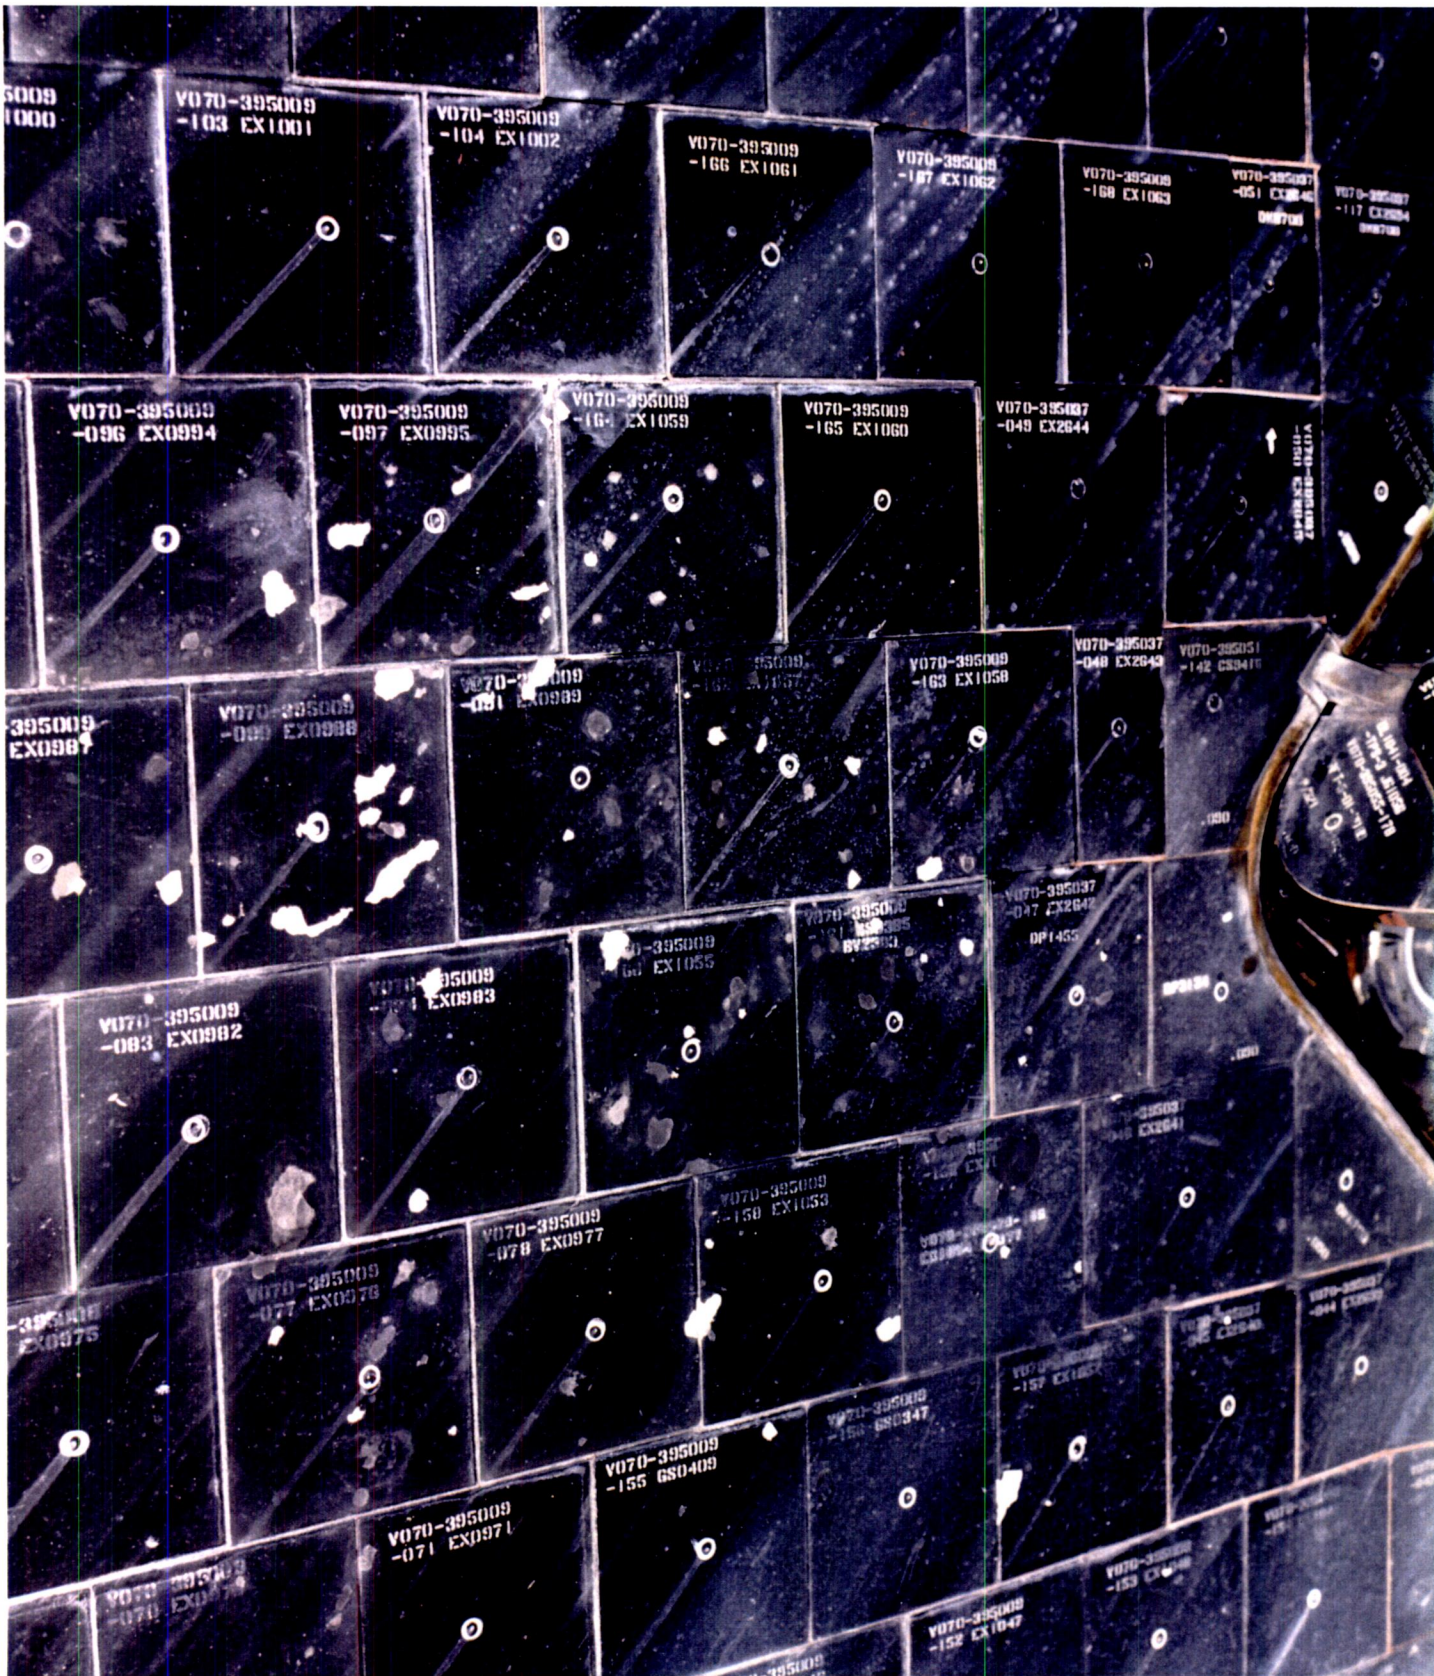
Photo 19 : Lower Surface Tile Damage

Tile damage sites aft of the LH2 ET/ORB umbilical were greater than usual in number and size (116 total with 13 larger than 1-inch). The damage was most likely caused by a combination of impacts from umbilical ice and shredded pieces of umbilical purge barrier material flapping in the airstream.
